Monitoring Data Record

Project Title: R-2214A COE Action ID: 200330312

Stream Name: Mud Creek Tributary (Site 3) DWQ Number: 011715

Year 2 – October 2006

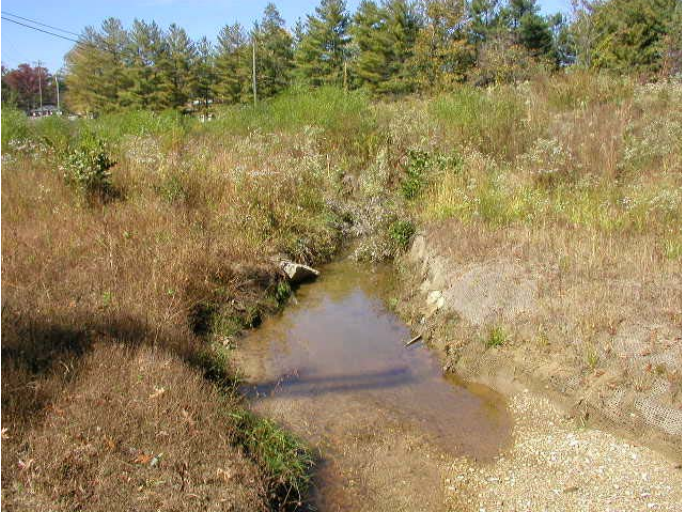
Photo 7

The stream is stabilized for the Year 2 Summer evaluation. As noted in last year's report the lower portion of the stream was reconstructed to have a better tie-in with the existing channel. Photos 7 and 8 were taken of the new alignment with the existing channel. NCDOT will continue to monitor this stream relocation.
